December 16, 2013

**Re: Construction Monitoring Inspection Report  
Asbury Woods Condominium Association, Justice, Illinois  
Building 8108  
WEC Project No: 13C-511**

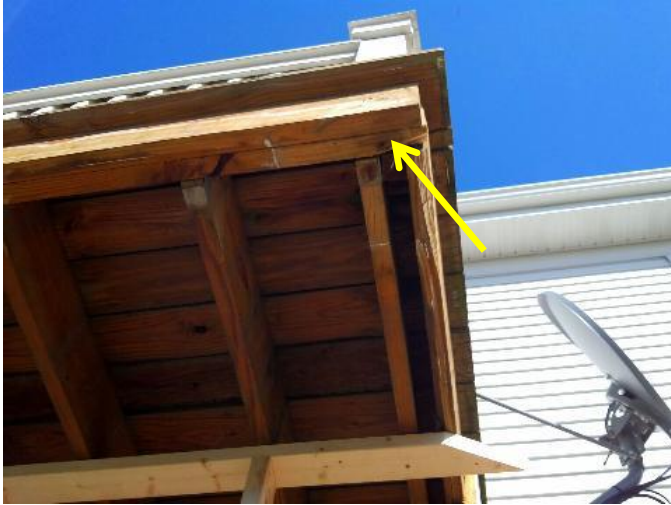
- The deck construction consisted of 4x4 columns that were connected to the concrete piers and patio slab using a stand off base; however, the top of the columns were simply toe-nailed into the bottom of the deck framing. The deck framing consisted of a double 2x8 rim with 2x8 joists spaced at 16" on center. The joists were connected to the outer rim joist and ledger using joist hangers; however, many of the joist hangers did not have nails installed to the joist itself. The columns were clad with masonite trim that was blocked out to make the columns appear to be approximately 6x6.

- The decks lacked lateral stability due to the columns being a 4x4 as well as not being properly attached at the top to the deck framing. The connection used during the original construction created a hinge affect at the top of the column which ultimately is not a safe way to construct the decks.

View of the double rim joist and single outside joist. The existing 4x4 columns were noted to be toe-nailed into the bottom which is not the proper way to attach a column to the deck framing.

- All 4x4 columns were replaced with 6x6 columns and the columns were run to the bottom of the deck boards. In addition, the outside joists were doubled up and thru bolts were installed to connect the joists to the columns. The columns were wrapped with painted trim to match the existing look of the decks.
- All concrete piers were replaced with 12" diameter concrete piers that were installed a minimum of 42" deep. All columns were mounted to the piers using stand-off bases.
- All existing joist hangers were reused and missing nails were installed.
- All decking and railings were replaced with new. The new railings were installed a height of 42" above the decking.

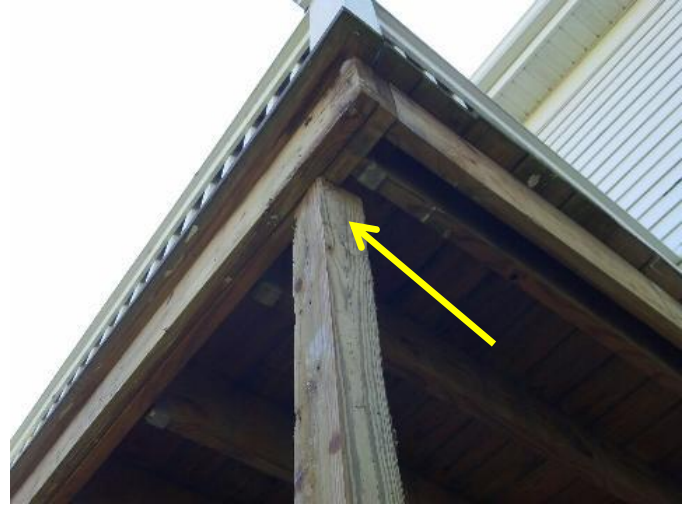
View of existing 4x4 column in place prior to removal. Note the column is only in contact with the inside member of the double 2x8 rim joist. This creates an unstable deck condition.

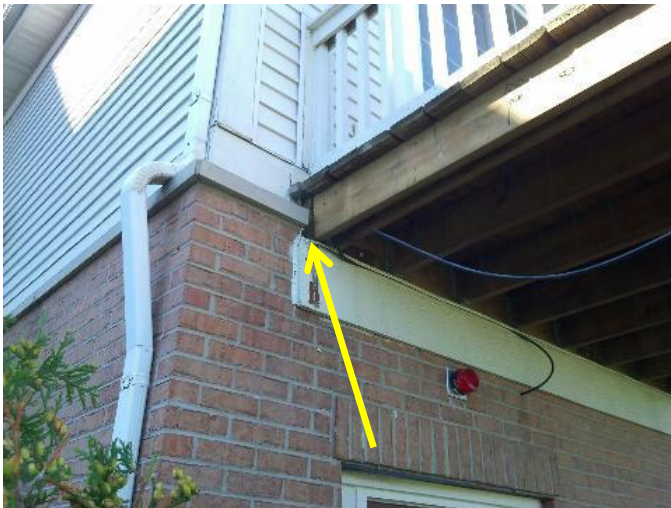
The outside joists were observed to be pulled away from the ledger board at several locations. All joists had to be re-secured to the ledger boards during the repair project to ensure the safety of the decks.

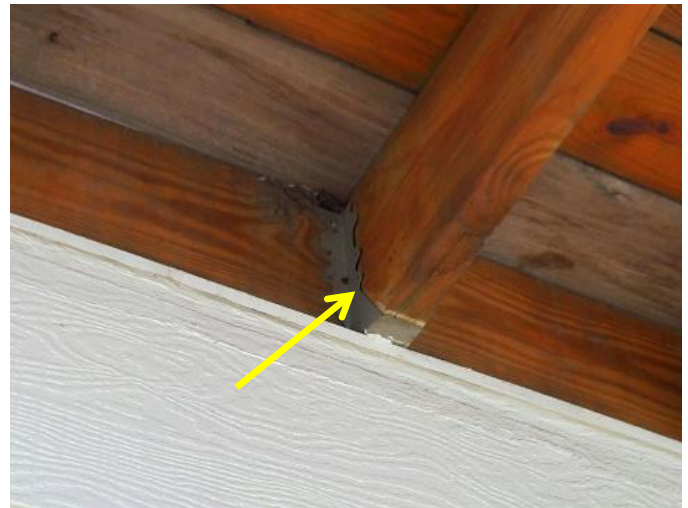
Several of the joist hangers did not have nails installed between the joist hanger and joist. The joists cannot be properly tied to the ledger board without fasteners installed in all joist hanger holes.

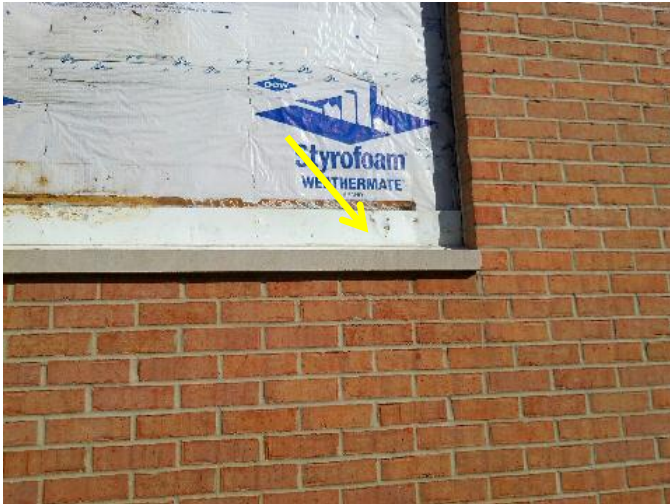
- Flashing was installed between the vinyl siding and brick; however, the flashing was not installed behind the building wrap and can allow water to infiltrate behind the flashing and down into the brick wall cavity.

Typical flashing installed between the panels and brick. Note the flashing is installed on top of the building wrap. The flashing needs to be installed behind the building wrap and the top edge of the flashing needs to be sealed to the wall sheathing in order to be effective.

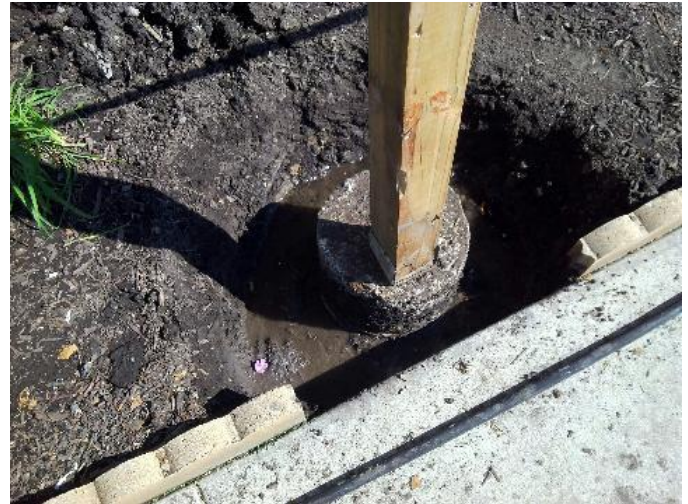
- The concrete piers at the larger decks were excavated and Inside Out determined that the depth of the piers did not meet the minimum of 42 inches. Many of the piers were noted to only be 20"-30" deep or less in some cases.

View of existing pier that was replaced during the repair project.

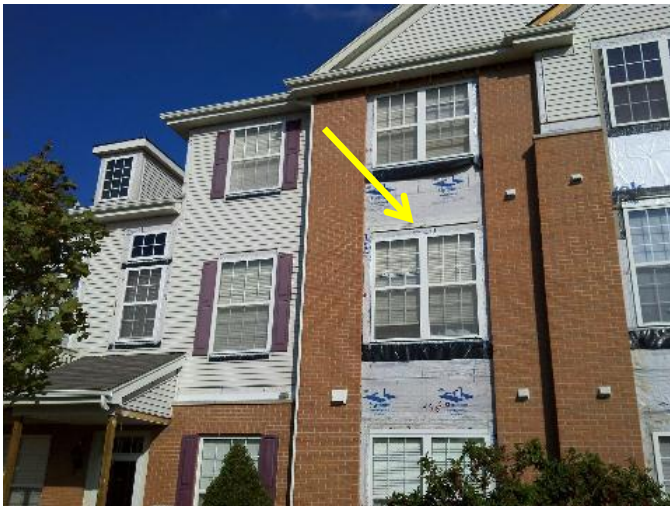
- Metal z-flashing was observed to be installed at the horizontal band trim; however, the flashing was installed on top of the building wrap. Z-flashing is to be installed behind the building wrap and sealed to the wall substrate using a self-adhering flashing tape rather than Tyvek seam tape. Tyvek seam tape is manufactured to bond seams in Tyvek building wrap together and is not be used as flashing tape. The improper installation of z-flashing was noted to be a partial cause of water infiltration into the buildings.

View of the locations at the building that panel siding is installed between the windows. Note the z-flashing installed at the top of trim boards but the flashing is installed on top of the building wrap in lieu of behind the building wrap.

- All window, door, and band trim was replaced with new as well as the fascia and panels.
- New z-flashing was installed at all window heads and horizontal trim. The z-flashing was installed behind the existing building wrap and the top edge of the flashing was sealed to the wall substrate using self-adhering flashing tape.
- It is noted that the flashing between the siding and the brick was not repaired. Future projects should include the removal of the siding at these locations in order to install new flashing in the same manner as the new z-flashing was installed.
- New self-adhering flashing was installed around the perimeter of the windows and doors.

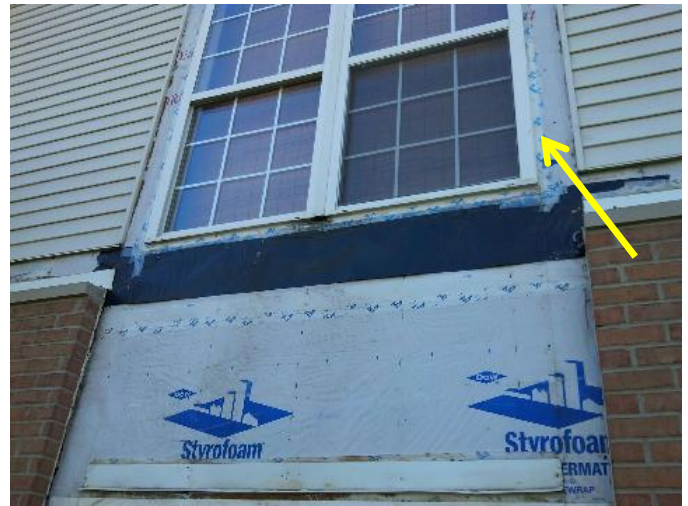
- Upon removal of the window trim, WEC observed that the windows did not have proper flashing installed around the perimeter of the windows. The building wrap appeared to wrap inside the wall openings and the window nailing flange was set on the outside of the building wrap. Tyvek tape was then installed between the nailing flange and the building wrap. Head flashing was not installed above the windows as required by most all window manufacturers. Z-flashing was installed above the horizontal trim that was installed above the windows; however, the flashing was not installed properly and can allow water to infiltrate behind the flashing and reach the head of the window.

Note the Tyvek tape installed around the perimeter of the windows which is not an acceptable method of window flashing.
